Contract #: 04-0120F4Cty: SF/ALA Rte: 80 PM: 13.2/13.9File #: 69.28**WELDING INSPECTION REPORT****Resident Engineer:** Pursell, Gary**Address:** 333 Burma Road**City:** Oakland, CA 94607**Report No:** WIR-003934**Date Inspected:** 20-Sep-2008**Project Name:** SAS Superstructure**OSM Arrival Time:** 2130**Prime Contractor:** American Bridge/Fluor Enterprises, a JV**OSM Departure Time:** 830**Contractor:** Zhenhua Port Machinery Company, Ltd (ZPMC), Changxing Island **Location:** Shanghai, China**CWI Name:** Lin Yan Hua**CWI Present:** Yes No**Inspected CWI report:** Yes No N/A**Rod Oven in Use:** Yes No N/A**Electrode to specification:** Yes No N/A**Weld Procedures Followed:** Yes No N/A**Qualified Welders:** Yes No N/A**Verified Joint Fit-up:** Yes No N/A**Approved Drawings:** Yes No N/A**Approved WPS:** Yes No N/A**Delayed / Cancelled:** Yes No N/A**Bridge No:** 34-0006**Component:** OBG-PMT**Summary of Items Observed:**

Caltrans Quality Assurance (QA) Inspector, Mike Hasler was present to observe the fitup, welding and related activities associated with the fabricating of Caltrans Orthotropic Box Girder (OBG) and Tower, for the San Francisco Oakland Bay Self Anchored Suspension

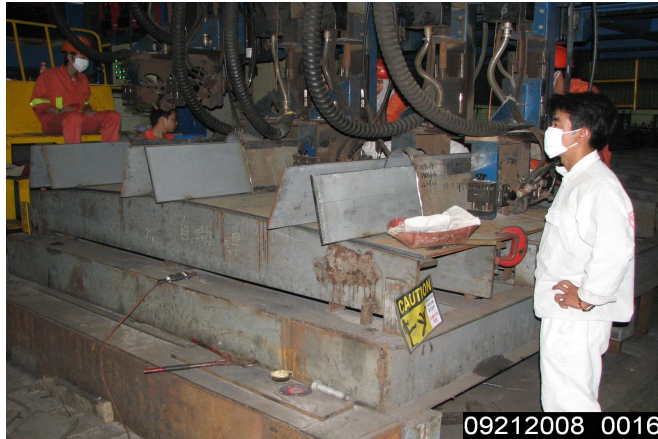
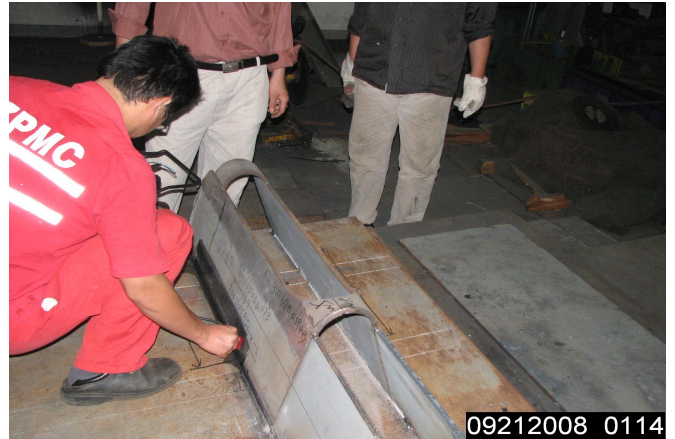
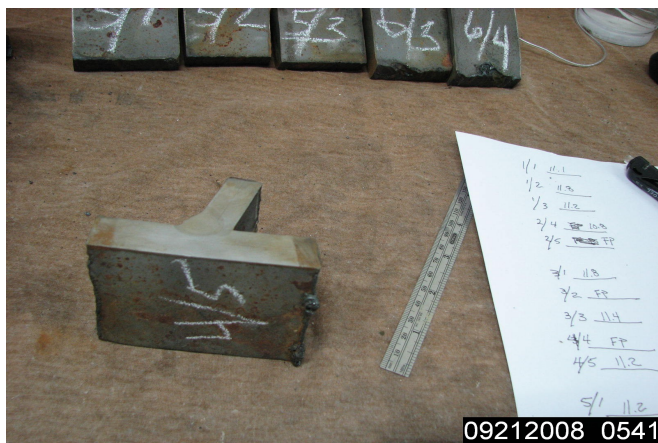
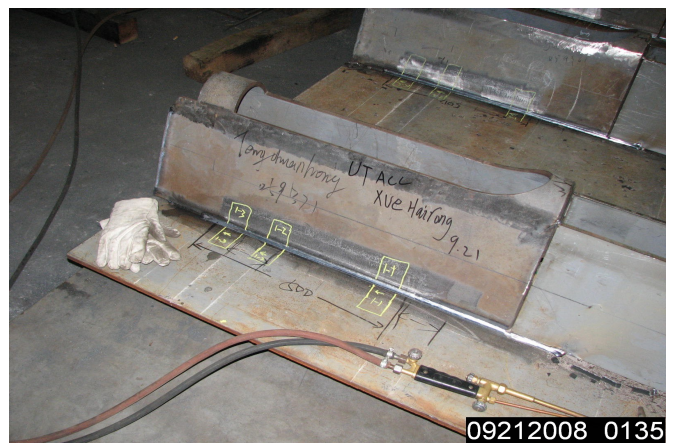
Bay 1: Caltrans QA inspector monitored OBG Production Monitoring Test (PMT) for deck panels DP416-001 and DP335-001. Visual inspection of tack welds and root gap was performed by ABF, ZPMC and Caltrans. The magnetic particle test (MT) of the tack welds was performed by ZPMC QC/MT inspector identified as Xu Hai. Caltrans QA inspector verified and documented the welding amperage, voltage and travel speed during the gas metal arc welding (GMAW) and submerged arc welding (SAW) process of welds 1 thru 6. At the completion of the GMAW root pass and SAW cover pass. The welds were visually inspected by ABF, ZPMC and Caltrans. Caltrans QA inspector witness ZPMC QC/UT inspector identified as Xue Hai Rong inspect the welds for depth of penetration and conformance. Caltrans QA inspector identified designated locations for macro sampling per contract requirements. The macroetch samples were evaluated with a 7X optical comparator and accepted by ZPMC, ABF and Caltrans. See Caltrans U-ribs PMT Inspection Sheet, dated 9-20-08 and ZPMC production monitoring test plate inspection report, dated 9-21-2008 for additional information. The following picture illustrates welding of the PMT and typical macroetch specimen identified as 4-5.
